Home Inspection Report

1234 Sample Street
Chesterfield, Missouri 63017

Prepared for: Home Buyers

Prepared by: Maxwell Home & Property Solutions, LLC
357 Penrod Road
Troy, Missouri 63379

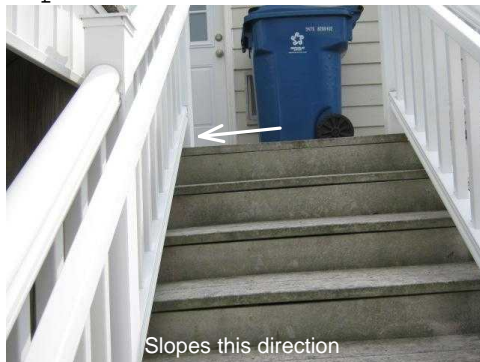
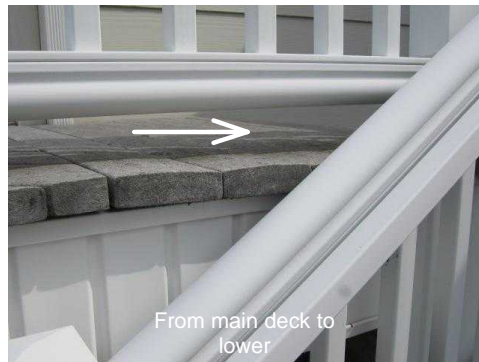
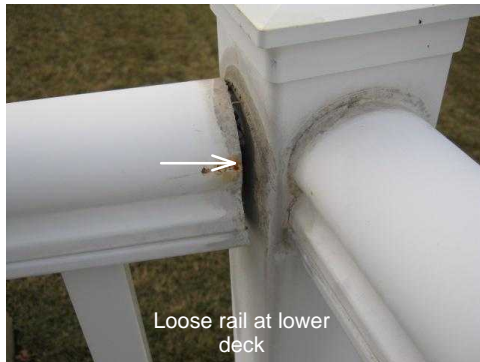
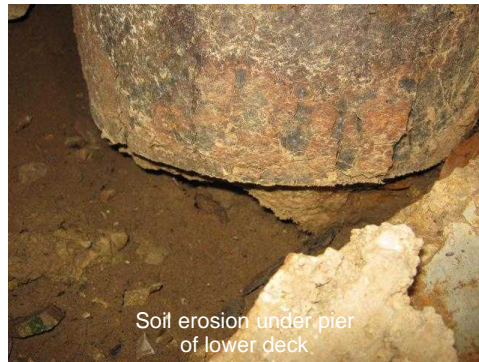
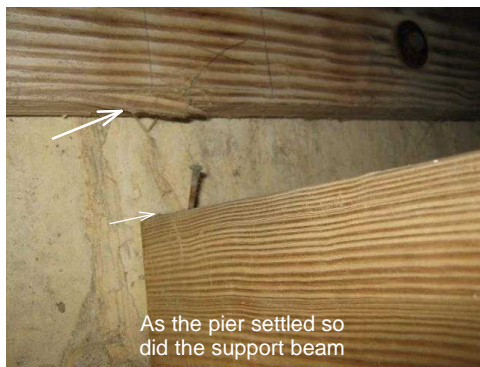
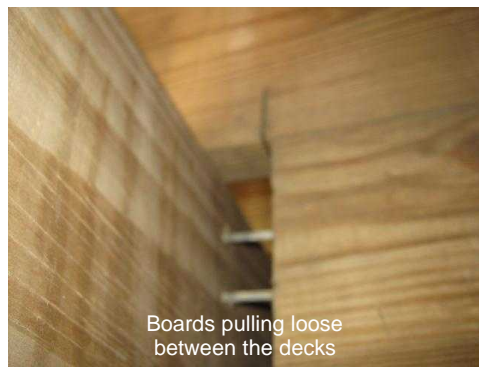
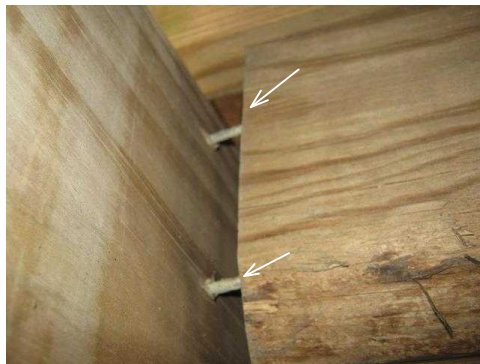
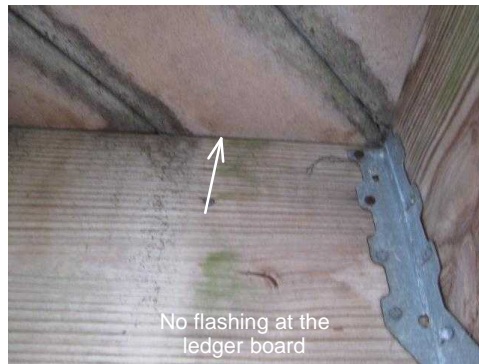
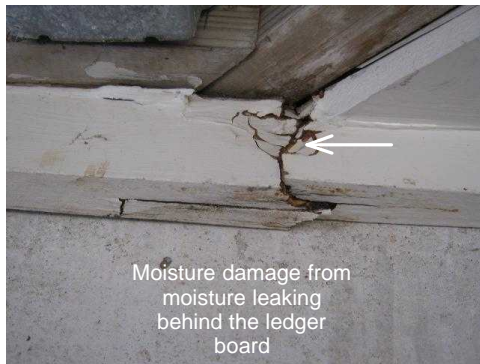
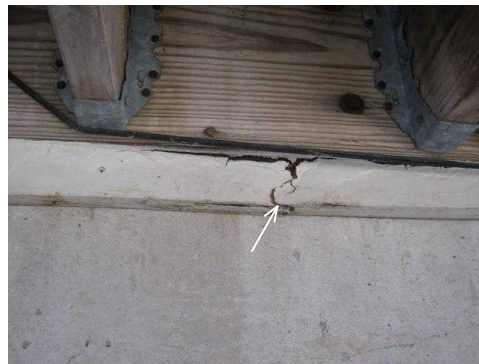
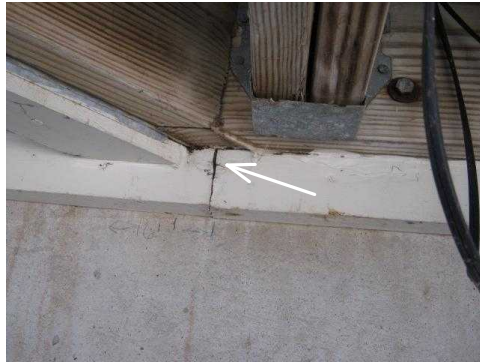
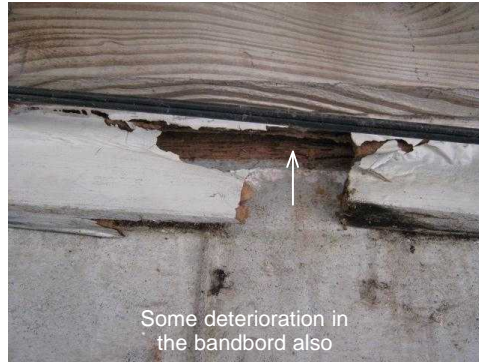
5. Defective Deck: Wood and Composite Materials- There is some slope to the deck at the stairs of the lower deck and at the short stairs to the lower deck. One concrete pier has settled causing the support beam to sag and boards between the deck are also separated.
Loose rail noted at lower deck.
There is no flashing installed at the decks ledger board, when the ledger board is installed directly over hardboard siding without a flashing, damage can result from moisture penetration behind the ledger board.
Moisture damage was noted behind the ledger board - see attached pictures.
A qualified contractor is recommended to evaluate deck and estimate repairs.

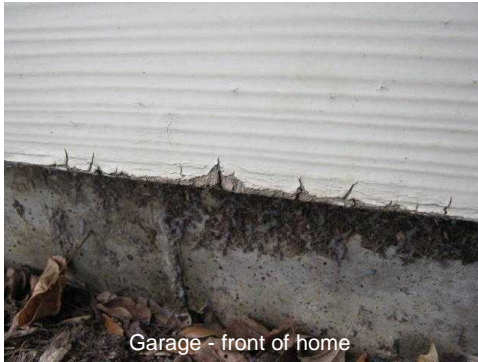
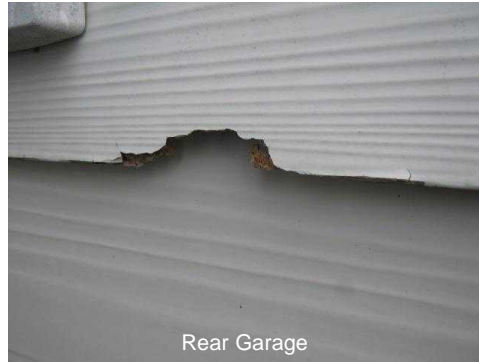
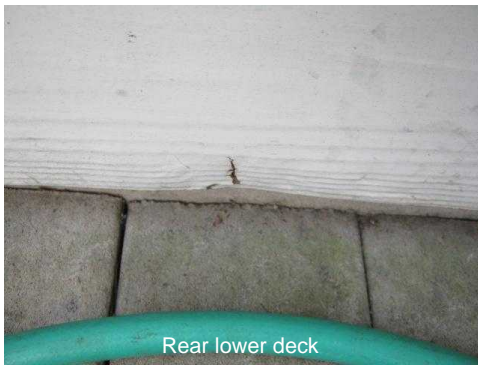
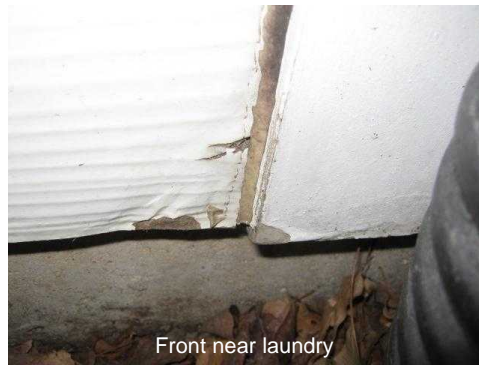
2. Defective Type: Hardboard- Deterioration from moisture was noted along the bottom edges of the siding at the front and rear of the garage, and at the front and rear of the home.
Siding corner loose at the rear.
A qualified contractor is recommended to evaluate siding and estimate repairs.

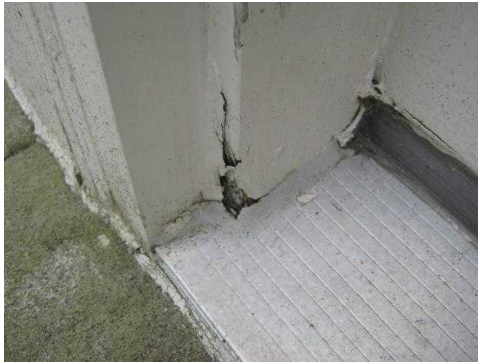
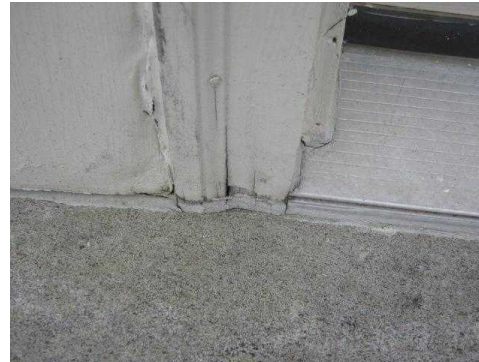
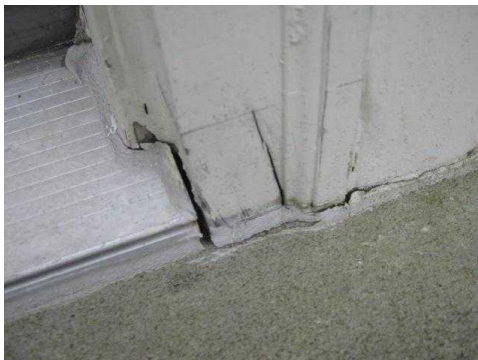
3. Defective

Trim: Wood, Composite material- Deterioration and damage from moisture noted at wood trim at rear deck area windows - recommend review and replace moisture damage trim as needed

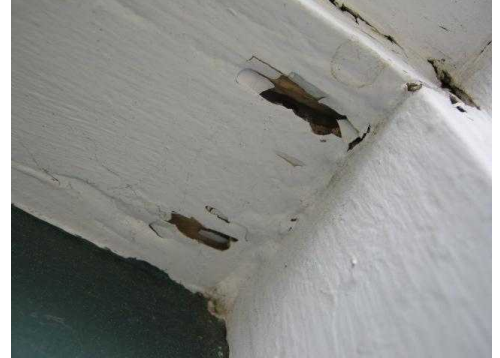
6. Defective

Entry Doors: Metal Clad- Termite damage noted at wood trim - recommend repair
See separate termite inspection for treatment recommendations

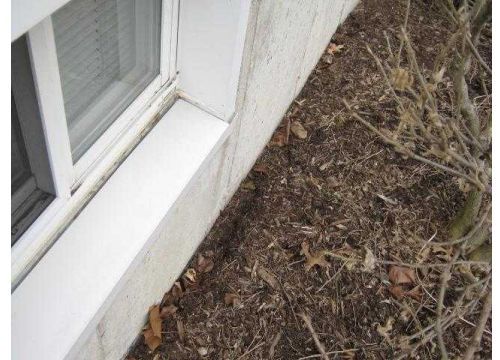
7. Marginal

Basement Windows: . Loose aluminum trim

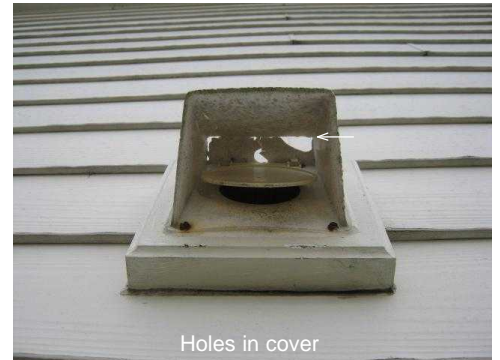
11. Defective

Vent Covers: . Vent fan cover at the rear will need replacement soon

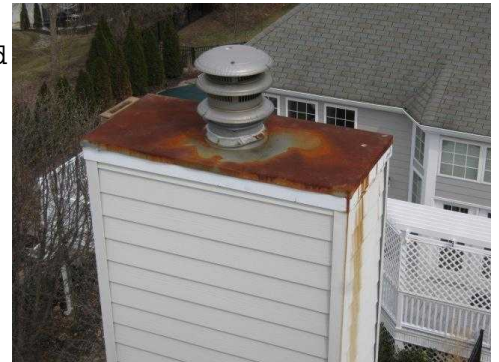
Right Side Chimney

10. Defective Chimney: Framed- The metal chimney crown is rusted - recommend metal be primed and painted

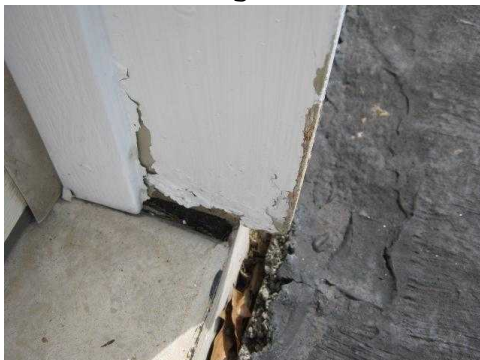
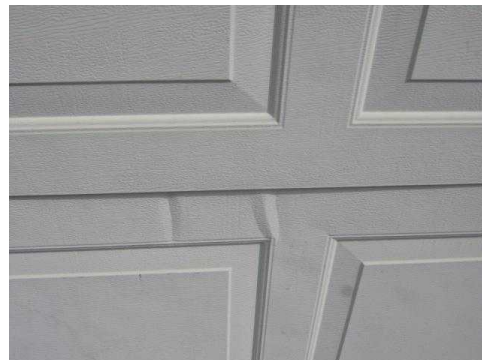
1. Type of Structure: Attached Car Spaces: 3
2. Acceptable Garage Doors: Metal- Some minor dents in the small door. Some minor deterioration from moisture noted at garage door trim - recommend routine painting of trim surfaces as needed to prevent moisture damage.

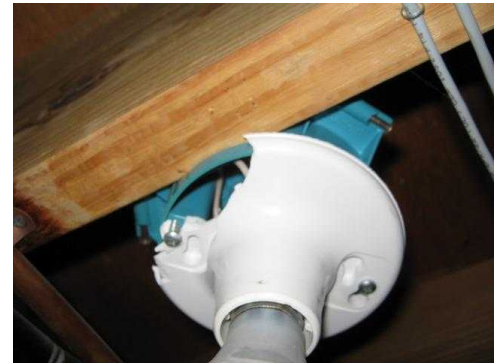
1. Not Inspected Unable to Inspect: 95%- Basement areas are mostly finished. Unable to inspect areas concealed by finish.
2. Acceptable Ceiling: Suspended ceiling, Drywall
3. Acceptable Walls: Drywall
4. Acceptable Floor: .
5. Acceptable Floor Drain: Visual inspection only
6. Acceptable Doors: Wood
7. Acceptable Windows: Vinyl
8. Defective Electrical: . Broken light fixture in unfinished area near water heaters - recommend replace

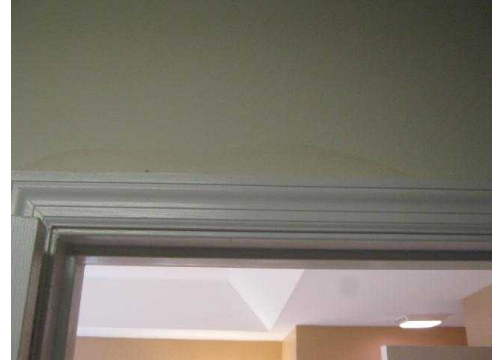
1. Acceptable

Closet: Walk In- moisture stains noted on wall in closet over the door. These do not appear to be active

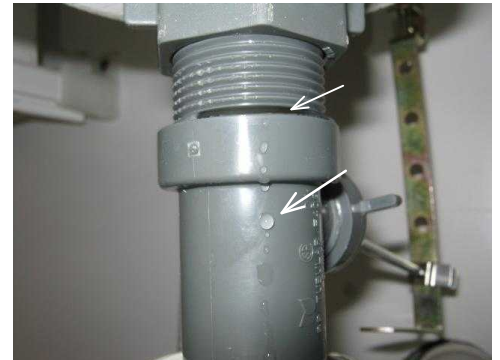
10. Defective

Faucets/Traps: . Leakage noted under the sink at pop up - recommend repair (sink at rear wall)

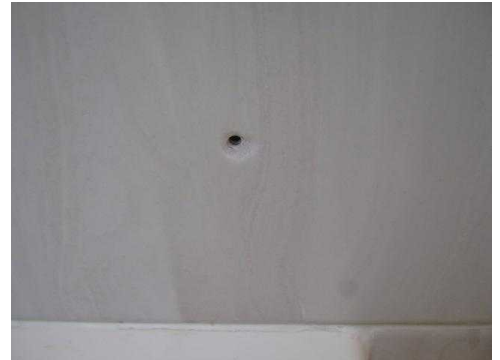
- 19. Acceptable Doors: Wood
- 20. Acceptable Windows: Vinyl
- 21. Acceptable Electrical: 120 VAC GFCI
- 22. Acceptable Counter/Cabinet: Composite and wood
- 23. Acceptable Sink/Basin: Synthetic Marble
- 24. Acceptable Faucets/Traps: .
- 25. Marginal Tub/Surround: Synthetic Marble- Recommend sealing open screw holes where shower doors have been removed.
Minor adjustments needed at tub drain

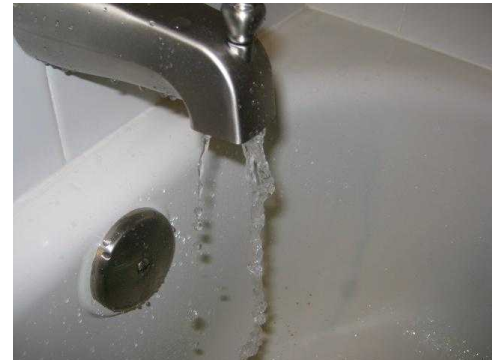
- 29. Acceptable Ceiling: Drywall
- 30. Acceptable Walls: Drywall
- 31. Acceptable Floor: Tile
- 32. Acceptable Doors: Wood
- 33. Acceptable Electrical: 120 VAC GFCI
- 34. Acceptable Counter/Cabinet: Wood
- 35. Acceptable Sink/Basin: Synthetic Marble
- 36. Defective Faucets/Traps: Moen/PVC- Very little hot water flow is present at tub faucet - recommend repairs

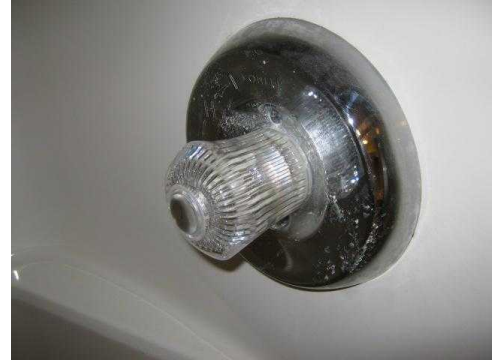
- 44. Acceptable Doors: Wood
- 45. Acceptable Electrical: 120 VAC GFCI
- 46. Acceptable Sink/Basin: Synthetic Marble
- 47. Defective Faucets/Traps: Kohler- No water flow at the shower faucet - recommend repairs

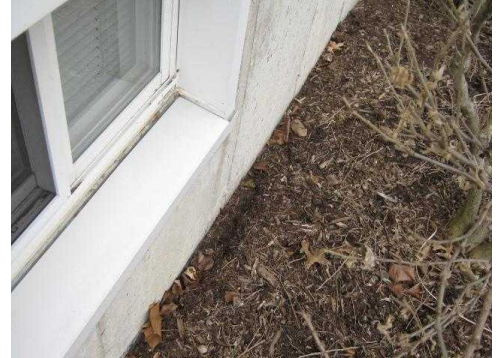
1. Fascia: Composite material- Some minor deterioration at leaking gutter corners
2. Basement Windows: . Loose aluminum trim

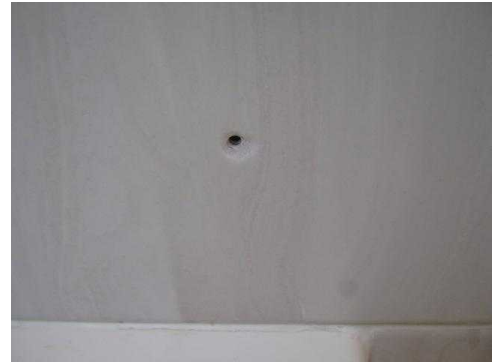
3. 2nd floor Hall Bathroom Tub/Surround: Synthetic Marble-
Recommend sealing open screw holes where shower doors
have been removed.
Minor adjustments needed at tub drain

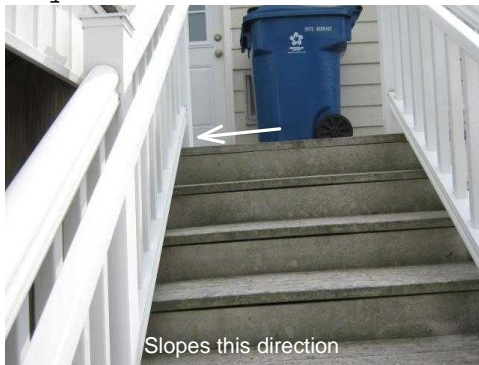
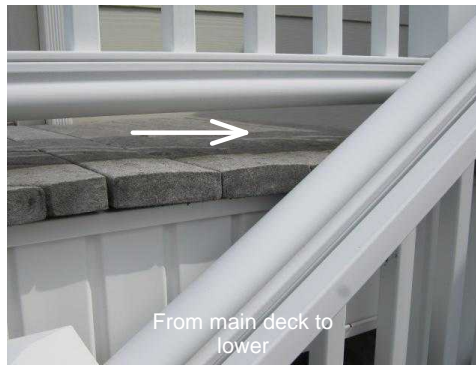
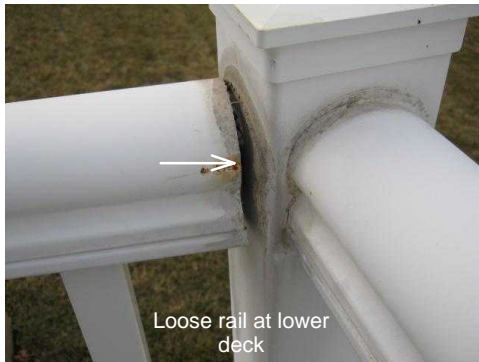
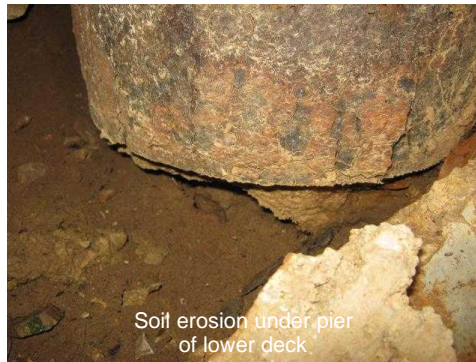
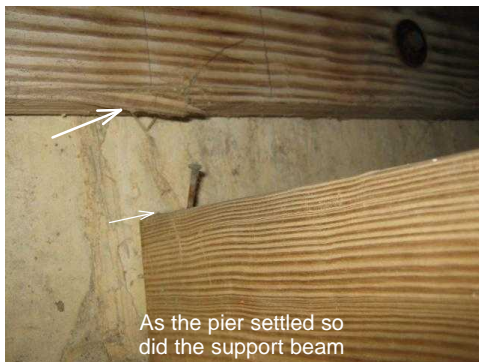
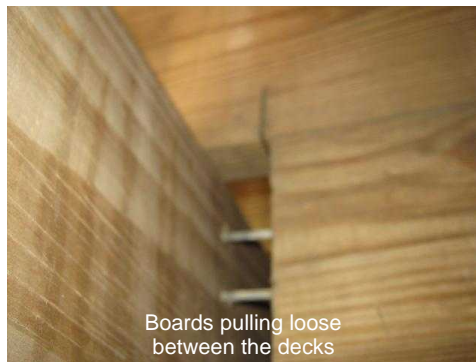
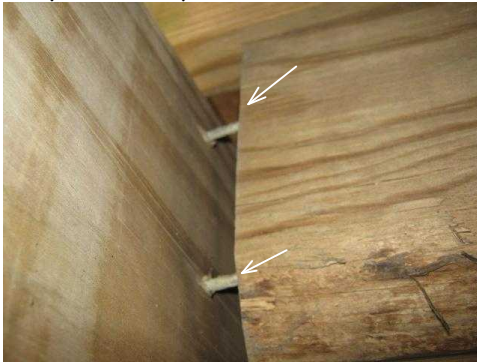
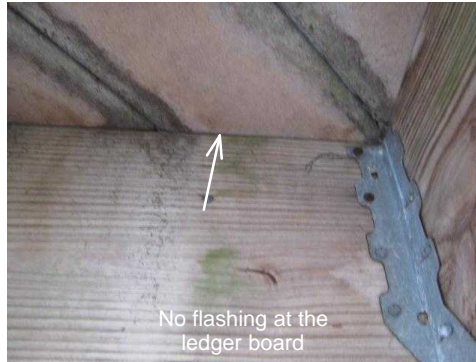
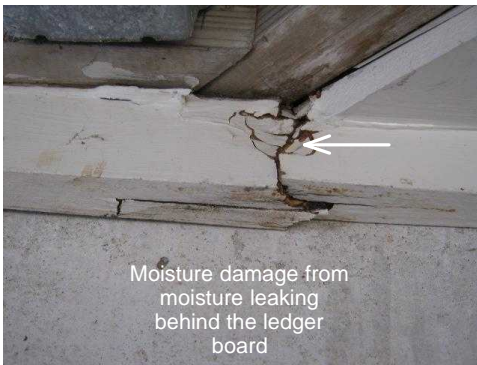
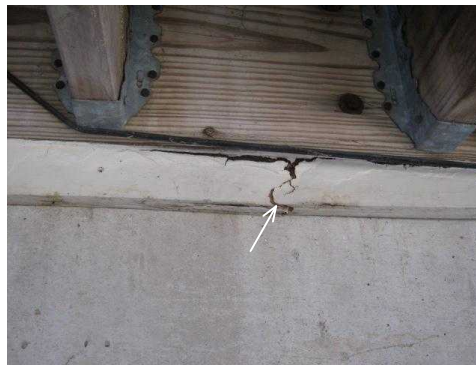
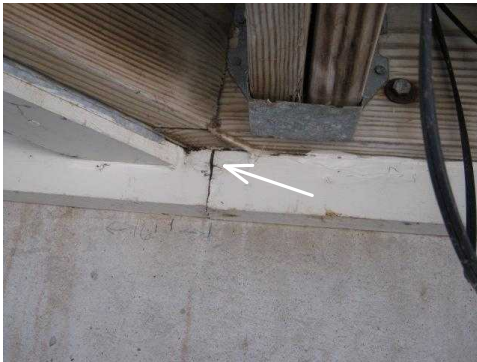
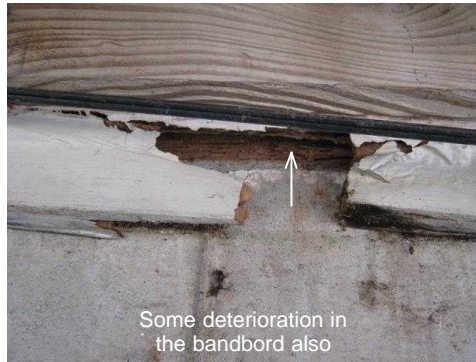
Loose rail noted at lower deck.

There is no flashing installed at the decks ledger board, when the ledger board is installed directly over hardboard siding without a flashing, damage can result from moisture penetration behind the ledger board.

Moisture damage was noted behind the ledger board - see attached pictures.

A qualified contractor is recommended to evaluate deck and estimate repairs.

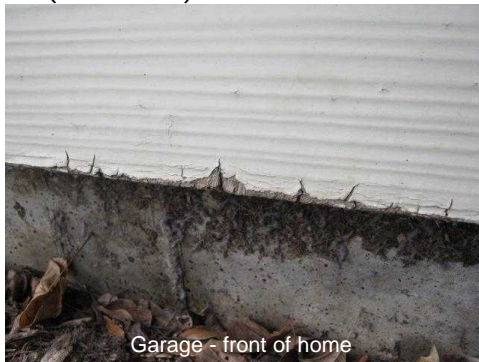
Garage - front of home

2. . Exterior Surface Type: Hardboard- Deterioration from moisture was noted along the bottom edges of the siding at the front and rear of the garage, and at the front and rear of the home.
Siding corner loose at the rear.
A qualified contractor is recommended to evaluate siding and estimate repairs.

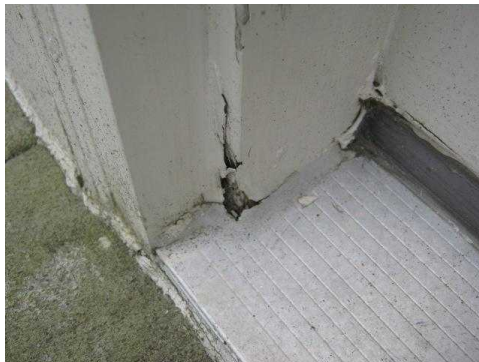
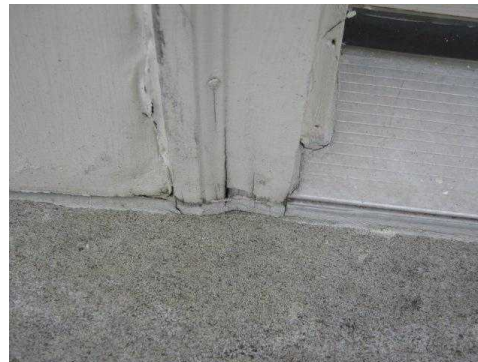
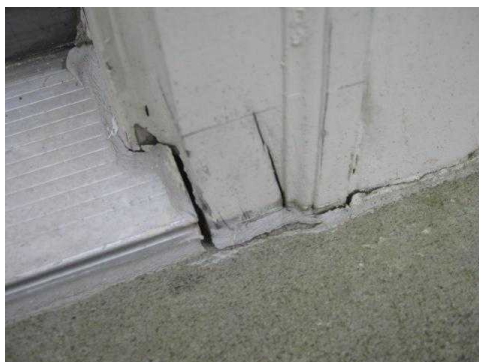
3. Trim: Wood, Composite material- Deterioration and damage from moisture noted at wood trim at rear deck area windows - recommend review and replace moisture damage trim as needed

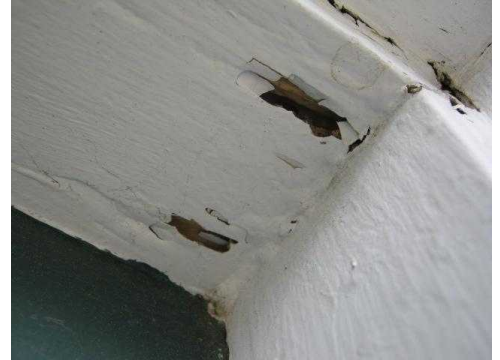
4. Entry Doors: Metal Clad- Termite damage noted at wood trim
- recommend repair
See separate termite inspection for treatment recommendations

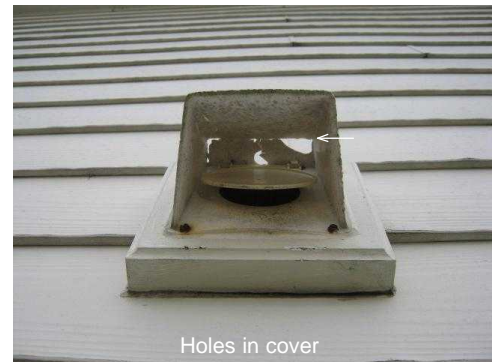
5. Vent Covers: . Vent fan cover at the rear will need replacement soon

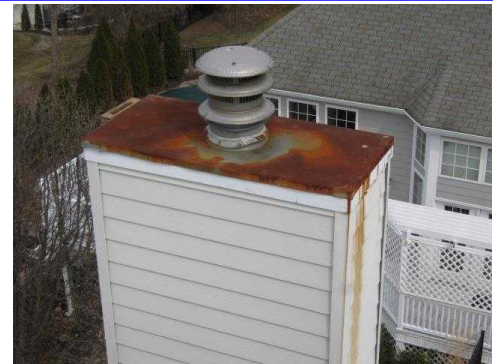
6. Right Side Chimney Chimney: Framed- The metal chimney crown is rusted - recommend metal be primed and painted

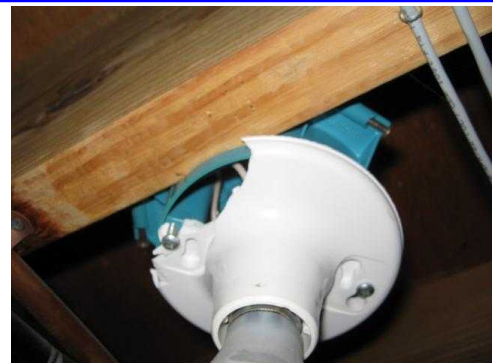
7. . Basement Electrical: . Broken light fixture in unfinished area near water heaters - recommend replace

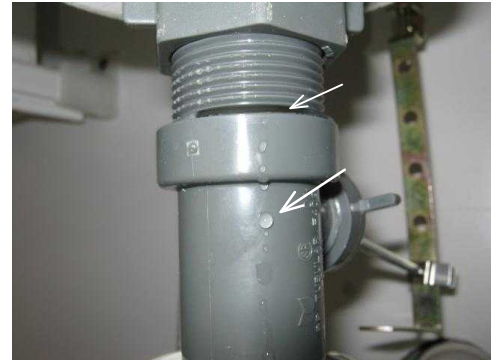
8. Master Bathroom Faucets/Traps: . Leakage noted under the sink at pop up - recommend repair (sink at rear wall)

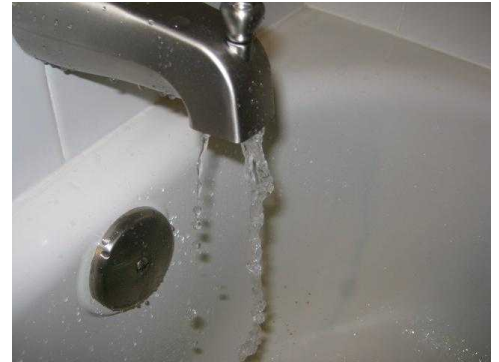
10. 1st floor Bathroom Faucets/Traps: Moen/PVC- Very little hot water flow is present at tub faucet - recommend repairs

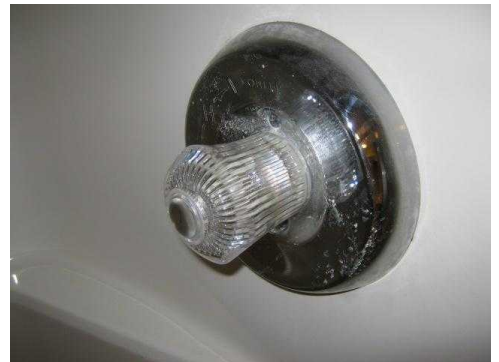
11. Basement Bathroom Faucets/Traps: Kohler- No water flow at the shower faucet - recommend repairs
